# Lotus Esprit S1/S2 Brake Servo Diagnostic Testing

Bill Galbraith 19 Oct 2026

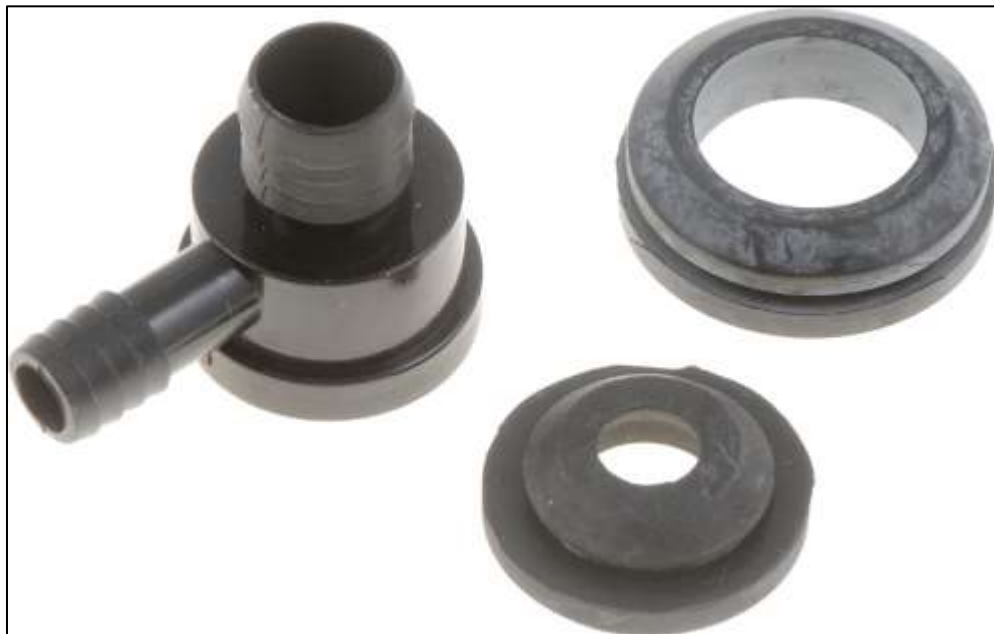
*Figure 2 - Dorman 80189 Check Valve*

I searched for another non-return valve that was the same size, but I was unsuccessful. I did find a grommet that will work, at least for buyers in the US. The part number is Dorman 80189 Check Valve. See Figure 2. It is available on Amazon and possibly at your local parts store. This is available from Amazon for under \$9, and probably your local parts store for a few dollars more. Dorman 80190 appears to be the same check valve without the grommets. It is confusing why they offered them like that, but whatever. It is possible that a check valve from a 2001 (give or take) Jeep Cherokee is the same size, but I did not get a caliper on one to check. I saw a video where the Dorman check valve 80189 was used on a Jeep Cherokee, so it is possible.

While the Dorman check valve will fit into the smaller grommet, and the smaller grommet fits into the larger grommet, there is nothing locking the two grommets together. You might be able to get by with some sealant between these two, but that should only be considered a temporary fix until you can get the correct check valve. If this joint fails, you will lose your power brakes, so will have to rely only on the manual braking.

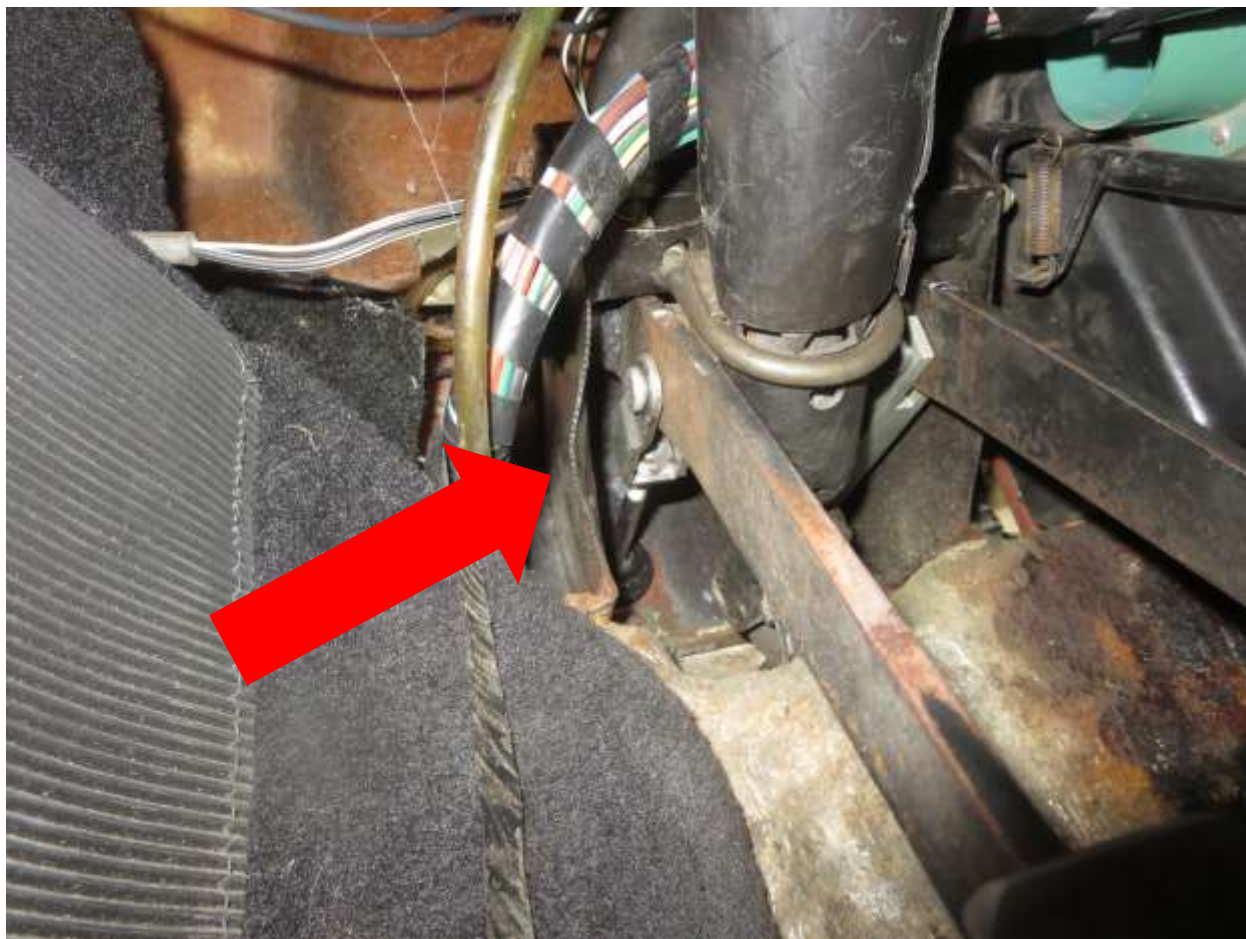
*Figure 4 Clutch clevis pin and hitchpin. Note bent pedal box for clearance*

Of course, installation is just the reverse of the removal. Getting the clevis pin into the brake pedal and input bar is challenging. You will be in the Lotus Position<sup>1</sup> on your back on the floorboard. I've found it easier to insert the pin if you bend the metal of the pedal box out a bit with a pair of pliers. See Figure 4.

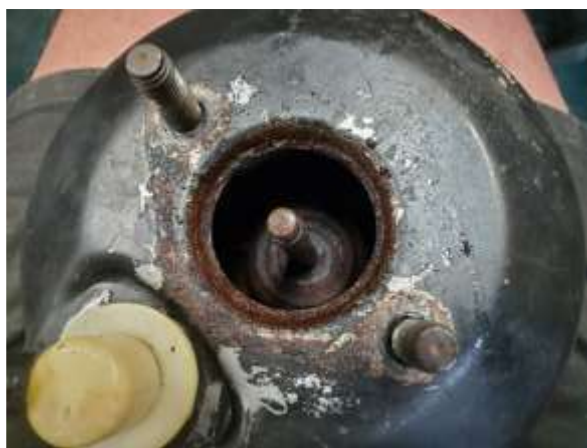
My servo happened to look like this:

I think we can see where it was leaking vacuum, between the servo and the BMC. There is a rubber O-ring there between the servo and BMC, but it can only do so much.

I cleaned up the rust, then primed and painted it. I attached the BMC to it so that I could bench test it. While it held a vacuum like that, once the input level was depressed, the vacuum was dumped immediately and completely. This servo needs to be rebuilt.

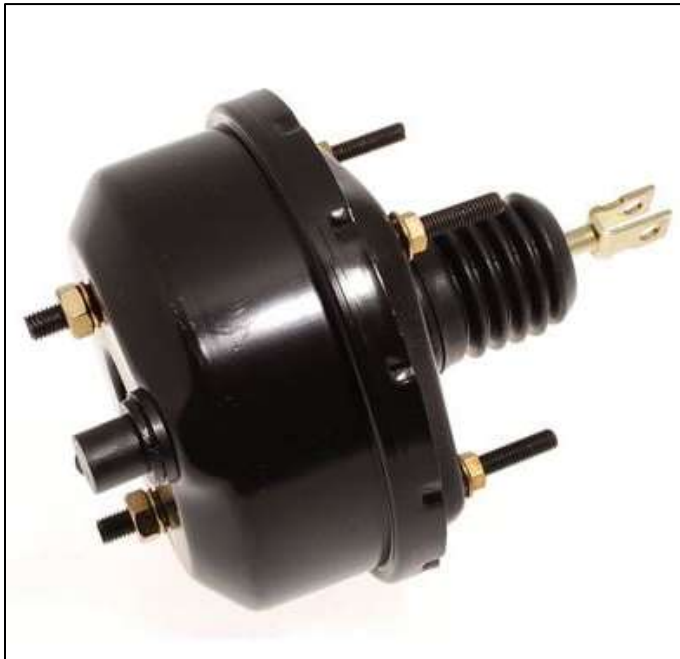
*Figure 5 Triumph TR6 servo*

I have a theory on that. Lotus needed to space the servo out from the firewall due to clearance issues with the servo and CMC. Therefore, it was a unique item from Girling. The difference is in the input shaft. The Lotus Esprit has a threaded rod which gets an extension bar from the brake pedal. Others, such as the Triumph TR6 as shown, have a fork that attaches directly to the brake pedal.

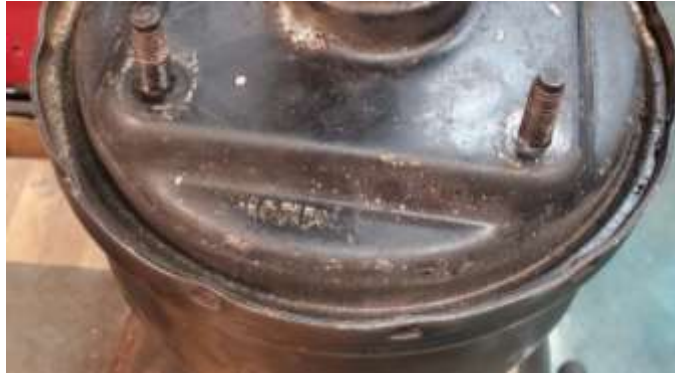
*Figure 7 Crimped edge on Esprit servo*

Since this is a unique item, they are scarce, and finding a rebuild kit is very difficult. On some servos, the two halves are rotated to allow some tabs to release to separate the two halves. On the Esprit servo, there are several places where it is crimped. See Figure 7.

I'm normally the type to tackle anything like this, but I started on it, and it was going to be a HUGE task to get all of those crimps straightened out or drilled out. Even if I did that, I didn't have the correct rebuild kit on hand, and didn't know if the Lockheed kit that I had would work, so I decided to let someone else rebuild it for me. There are several companies in the US that will do this. If you live in the UK, SJ Sportscars has rebuilt units with your exchange, and there are other companies that will rebuild yours for you. I HIGHLY recommend taking that approach.

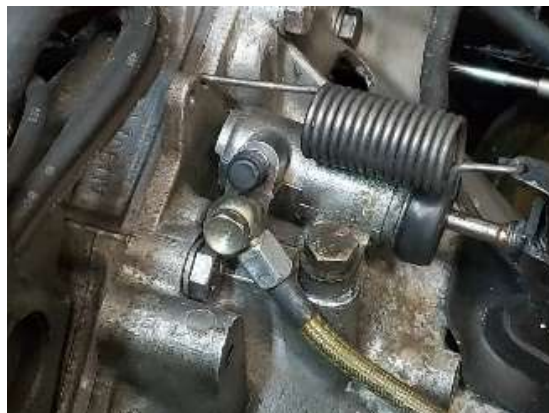
The other point is the location of the bleed valve. I've seen many cars with the bleeder below the hose connection. Dumb position, as you can't get all the air out. I don't know if it left the factory that way, or when the slave cylinder has been replaced over the years, that where it happened to be. I think it is better with the bleeder on top.
